**On-site Wastewater Treatment and Reuse Using Recirculatory  
Evapotranspiration Channels in Regional Queensland**

**Benjamin Mark Kele**

Masters of Applied Science

Central Queensland University

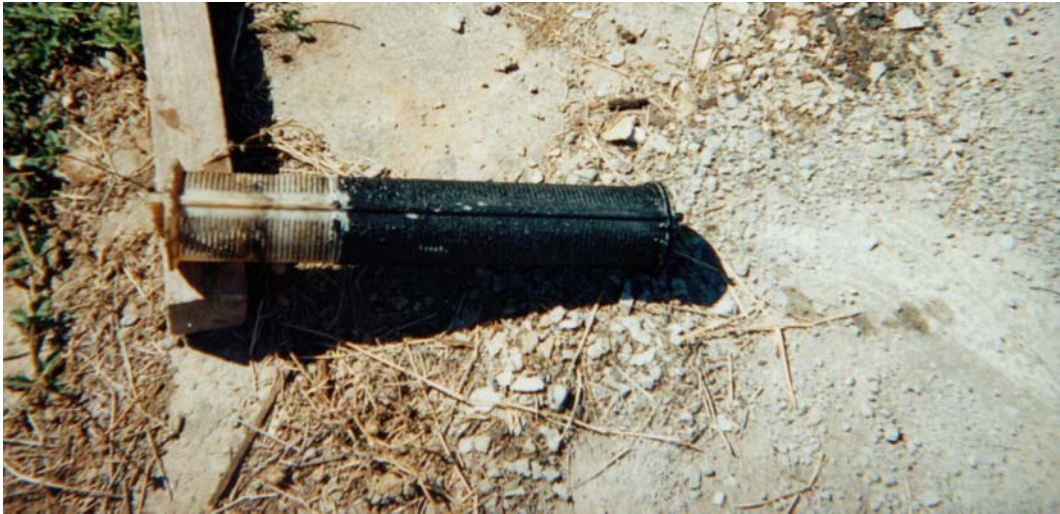
Figure 2.2 In-line filter after 3 months of operation

1. The removal of the filter from the outflow pipe
2. Washing the accumulated solids off the filter back into the main chamber of the primary treatment tank. Hot water was most effective though cold could be used.
3. Replacement of the filter in the outflow pipe

Zabel™ model in-line filters were installed in the outflow pipes of all the primary treatment tanks. Primary tanks that were 3000 L or less in size had the small style filter shown in Figure 2.2 and 2.3. Tanks with a capacity higher than 3000 L had a larger filter design installed. The in-line filters were installed as they remove some of the suspended solids found in primary treated effluent (Patterson *et al.* 2001; Patterson 2003).

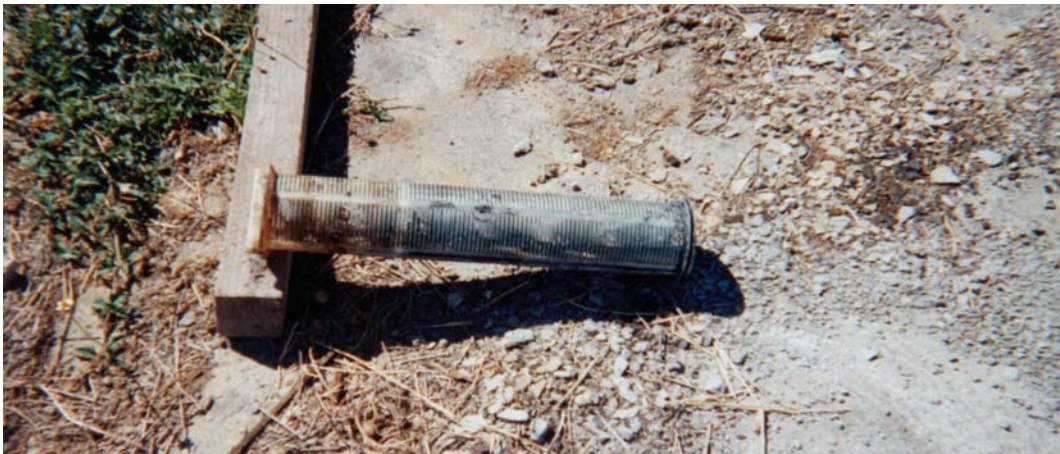
Figure 2.3 In-line filter after maintenance wash

Figure 2.3 shows the in-line filter after solids had been washed off. The filters at all of the sites were washed every three-months. The filters were effective and no problems were recorded with their maintenance.

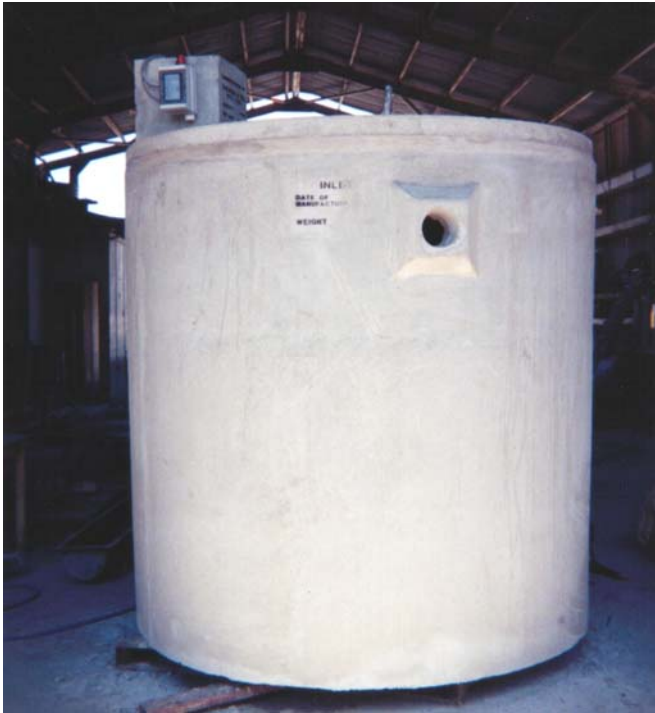
Figure 2.4 Holding tank

The primary treated filtered effluent then entered the RET channel holding tank. The primary tanks and the holding tanks were connected with 100 mm PVC drainage waste and vent (DWV) pipe. This pipe was installed according to the relevant codes so that it gravity fed to the holding tank with a one-metre in 30 metre fall.

Effluent was pumped to the RET channel when the pump was triggered by the pump time switch. The pump timer is located on top of the holding tank attached to the backflow prevention box (see Figure 2.4) The time-switch has a 24-hour cycle, with each hour split into four equal 15-minute segments. Under normal operating conditions the pump was run for 15-minutes every three hours. If the peak wastewater production times in the dwellings/facilities at the site were known the pump was set so that additional pumping-cycle occurred at these occasions. This potentially reduced the impacts of any hydraulic surges on the holding tank. Incorporated into the pump timer was a high and low-water alarm system. The alarm has a red flashing light as well as an audible component. Sensors in the bottom and the top of the tank triggered the alarm. The high water sensor indicated that the holding tank was full and the emergency overflow was in use. This would alert the householder or maintenance personnel to a possible pump failure. The low-water trickle sensor indicated that the holding tank was empty and that there was no water available to irrigate the plants in the RET channel. This sensor is designed to indicate a failure in the low-water trickle feed system.

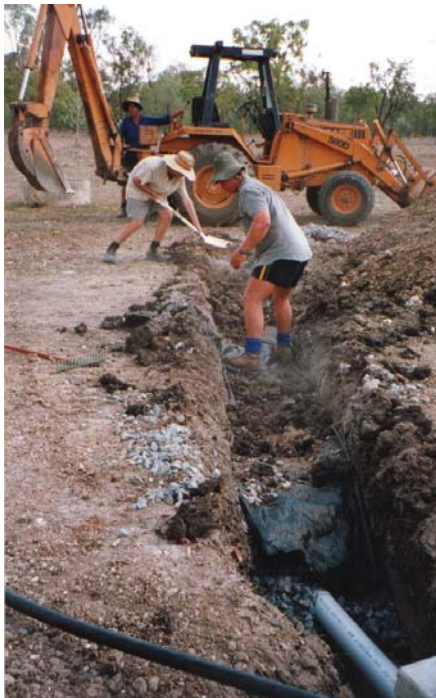
Figure 2.5 Construction of emergency overflow at Yaamba trial

An emergency overflow was installed at each trial site. Gravity fed soakage drains were used, as the emergency overflows are designed to operate when there was a power failure and the pumps could not operate. The soakage drain was designed according to the relevant legislation and constructed of 100 mm slotted DWV PVC pipe, aggregate, soil, and terra-firma matting (see Figure 2.5).

The size of the soakage drain depended on the volume of wastewater generated. It was not economically feasible to install solar panels and battery back-ups to ensure that the pumps worked during power-failures. The emergency overflow could also divert wastewater out of the system during large hydraulic surges. The emergency soakage drain was not designed to dispose of wastewater on a regular basis and the hydraulic loading could not realistically be calculated; for this reason it was not designed according to the requirements of AS: NZS 1547:2000. The emergency overflow protected public and environmental health by keeping the effluent underground.

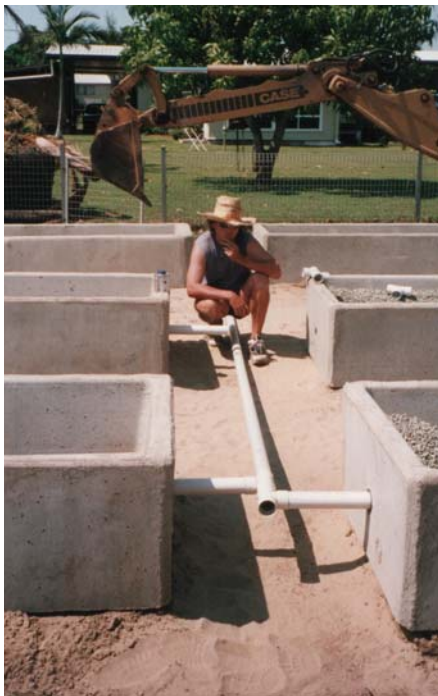
Figure 2.7 Herringbone RET channel design with central feed line

RET channels were installed in two different patterns; a channel-to-channel flow-through and a herringbone central line feed design (see Figure 2.7 and 2.8). In the flow-through design effluent had to pass through one channel length before it could enter the next one in the series, and it has to flow through all of the channel lengths before it can return to the holding tank. In the herringbone design the channel lengths are installed level in respect to one another. A central feed line distributes the pumped effluent to each channel length. The central feed line is connected to the return line so that any excess effluent may go back to the holding tank. The central feed line means that the effluent does not have to pass through all of the channel lengths before it is able to return to the holding tank.

The herringbone design was trialled to establish whether the accumulation of limiting factors occurred more evenly through all the channel lengths. Both types of RET channel designs were filled with the same substrates.

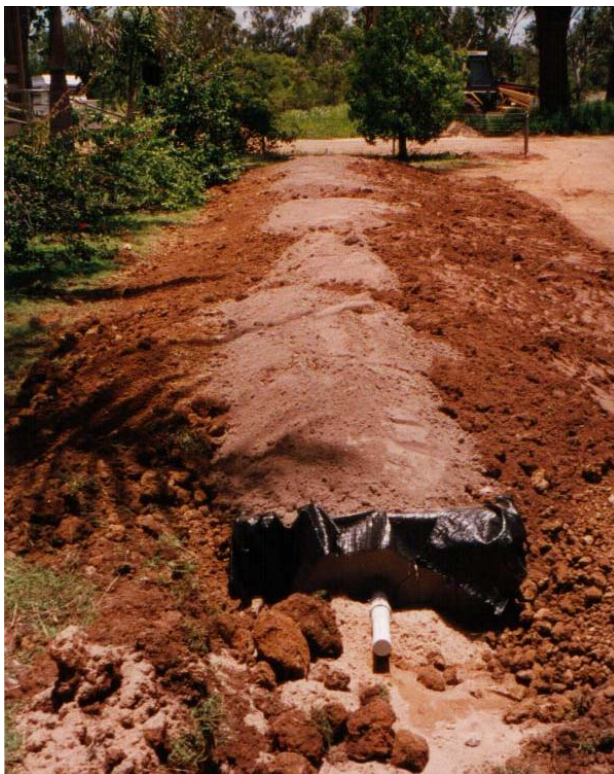
Figure 2.9 Soil filled RET channel at Anakie site

The excavated soil from beneath the RET channels is used to partly form the mound either side of the treatment system (see Figure 2.9). Additional fill was required at some sites to complete the sides of the mound. No requirements were placed on the

soil type used as fill. The requirement for fill was dependent on the type of slope found at each specific site. The mound is constructed so that its highest point in the middle of the RET channel is at least 200 mm higher than the top lip of the concrete channel. The soil mound needed to have sufficient height for the plants to be able to put roots through it and into the soil outside of the channel.

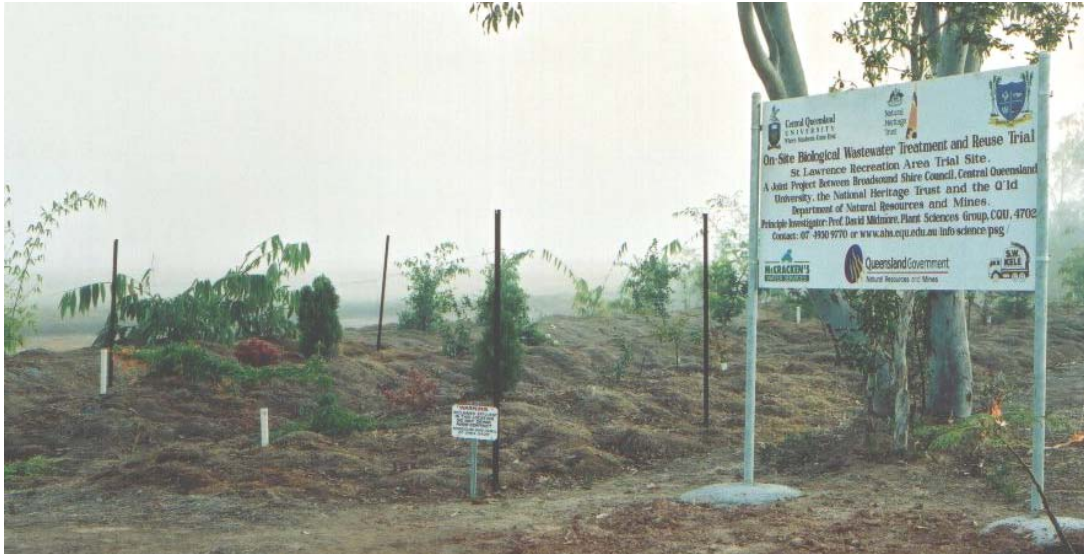
Figure 2.10 St Lawrence recreation area RET channels after planting

The RET channels should look like normal raised garden beds after planting (see Figure 2.10).

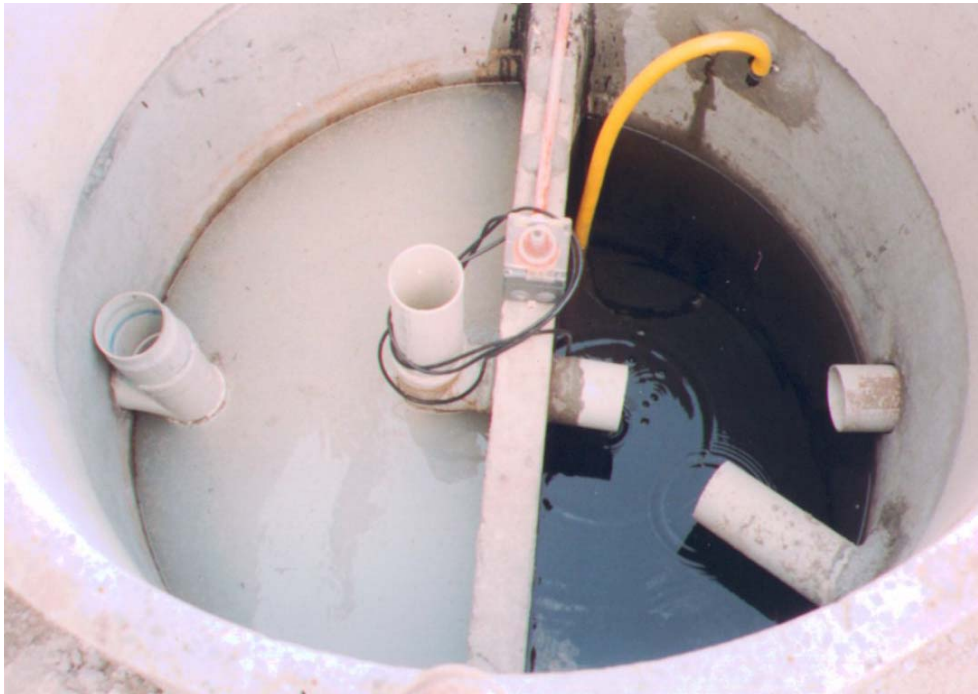
Figure 2.11 Interior of Rockhampton Holding Tank

The detention capacity of this tank is too small under the legislative requirements of new Australian and New Zealand standard (WS/13/1 2000). This tank was built before this standard was enacted; the design was not used at any other trial location.

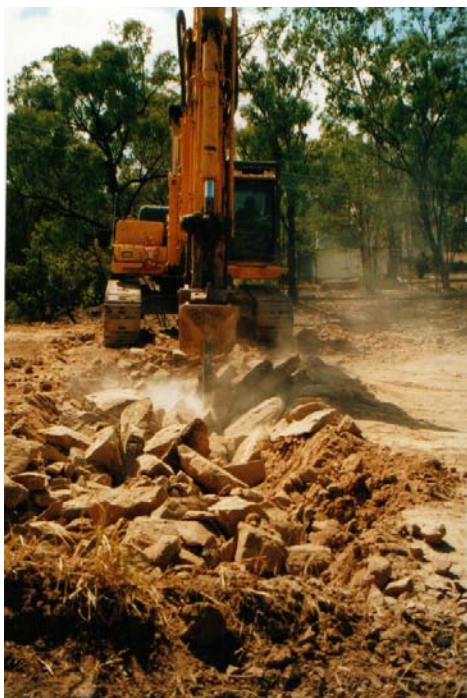
Figure 2.12 Digging RET channels in sandstone at Gem-Air caravan park

Gem-Air caravan was designed with additional treatment stages so that some of the treated effluent was of sufficient quality to use aboveground in the fossicking process. The original all-waste septic tanks were used for primary treatment. The primary treated effluent from these septic tanks was piped to an additional 4500 L all-waste septic tank. This dual-septic tank process reduced the adverse impacts of shock loadings and increased detention time. All septic tanks had in-line filters. The effluent from the 4500 L septic tank gravity fed to a 3000 L holding tank. The holding tank had an internal Venturi valve. The RET channels used at this site were of a special design. There was at the site on average less than 40 mm of topsoil. Underneath the topsoil is an unknown depth of solid sandstone. A thirty-ton excavator with a rock-pick attachment (see Figure 2.12) was required for any earthworks.

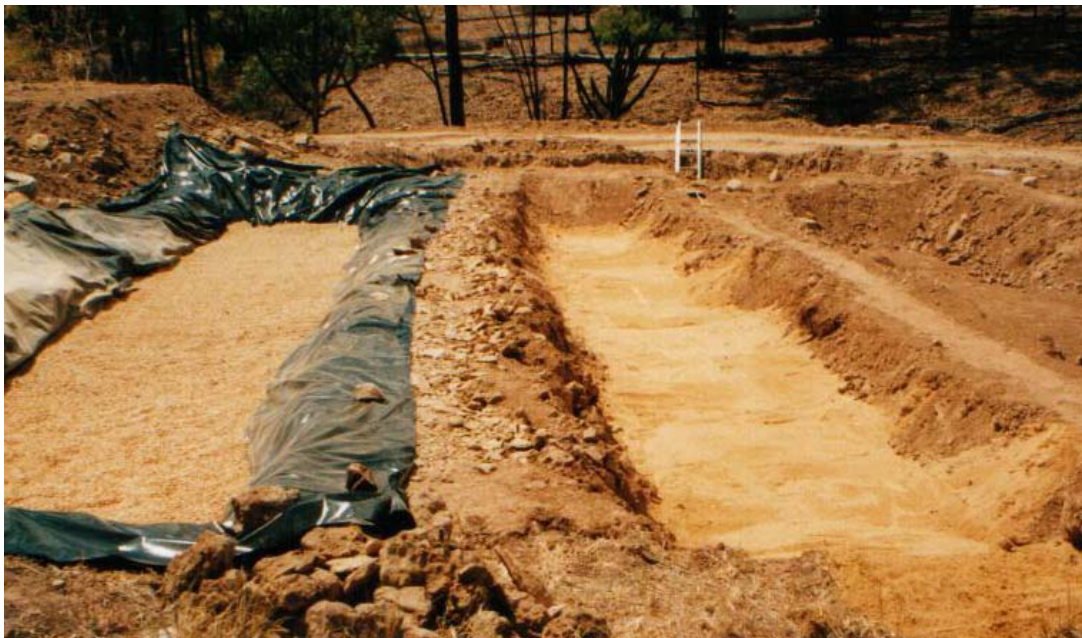
Figure 2.13 RET channels at various stages of construction at Gem-Air caravan park

Placing a concrete channel length inside of a solid sandstone excavation was deemed to be excessive. Instead four channels were dug in the sandstone. These channels were approximately twelve metres long, two metres wide, and 0.6 metres deep. This meant that each channel had approximately 14.4 kL total capacity. The bottom of the channel excavation was covered with 100 mm of sand (see Figure 2.13). The aim of the sand layer was to protect the pond-liner from any damage from rocks. The pond liner covered the channel excavation and the immediate top external environment (see Figure 2.13).

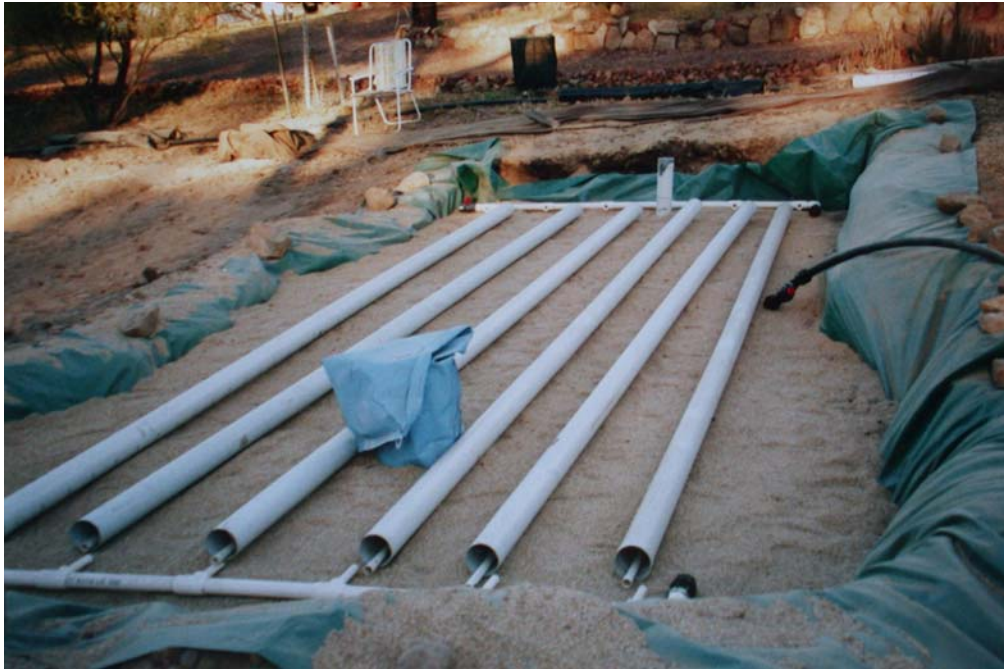
Figure 2.14 Recirculating sand-filter showing effluent distribution system

the aggregate layer. No effluent can use the pipework as a hydraulic short-circuit and travel through the pipework and back to the holding tank without passing through at least one type of RET channel substrate. A 10 mm white stone incorporating 5 mm red zeolite chips was used for aggregate. The aggregate layer was 80 mm deep. The terra-firma matting was placed over the aggregate. A sand layer 100 mm deep was put over the terra-firma matting. The sand is not adversely affected by salinity and sodicity and should help prevent clogging of the terra-firma matting, while also providing a more permeable substrate when the biomat forms. The channels were then filled with a red sandy loam with a clay amendment. After the effluent had passed through the RET channel system it went to a 2500 L tank. This tank collected effluent so that it could be pumped through a recirculating sand and zeolite filter. The internal dimensions of the sand and zeolite filter were approximately 3.9 m wide, 6.4 m long, and 1.8 m deep. This gave it a volume of c. 44.9 kL. Effluent was pumped to the filter and distributed through 20 mm PVC pipes laid through slotted 100 mm PVC DWV (see Figure 2.14). The filter is constructed of different grades and/or sizes of sand and red zeolite. The effluent is distributed over the top of the filter and flows down through the various layers and is then collected into a pump well. The filtered effluent is then pumped to another 2500 L tank. This tank pumps the filtered effluent back through the sand and zeolite filter. Automatically every sixth pump cycle the treated effluent was pumped through a bromine-chlorine disinfection unit into a 22 000 L storage tank. Figure 2.15 shows some of the tanks at the Gem-Air wastewater treatment system.

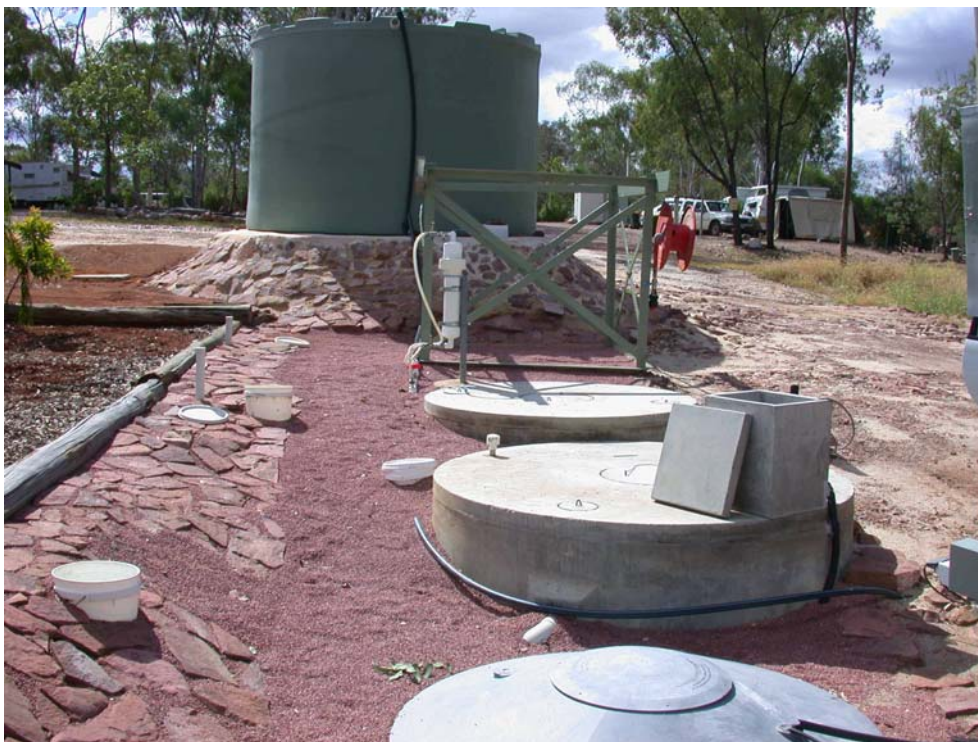
Figure 2.15 Gem-Air treatment tanks

The disinfected effluent was reused in the fossicking process by the residents in the park and by the owners of the Gem-Air for irrigation of the park. The system was designed so that excess effluent from the tourist season could be stored and used to irrigate the plants over the warmer months. At the end of each tourist season the plants growing in the RET channels were heavily pruned. This reduced their evapotranspiration rates during times when limited wastewater was produced at the site as well as encouraging new growth and nutrient use.

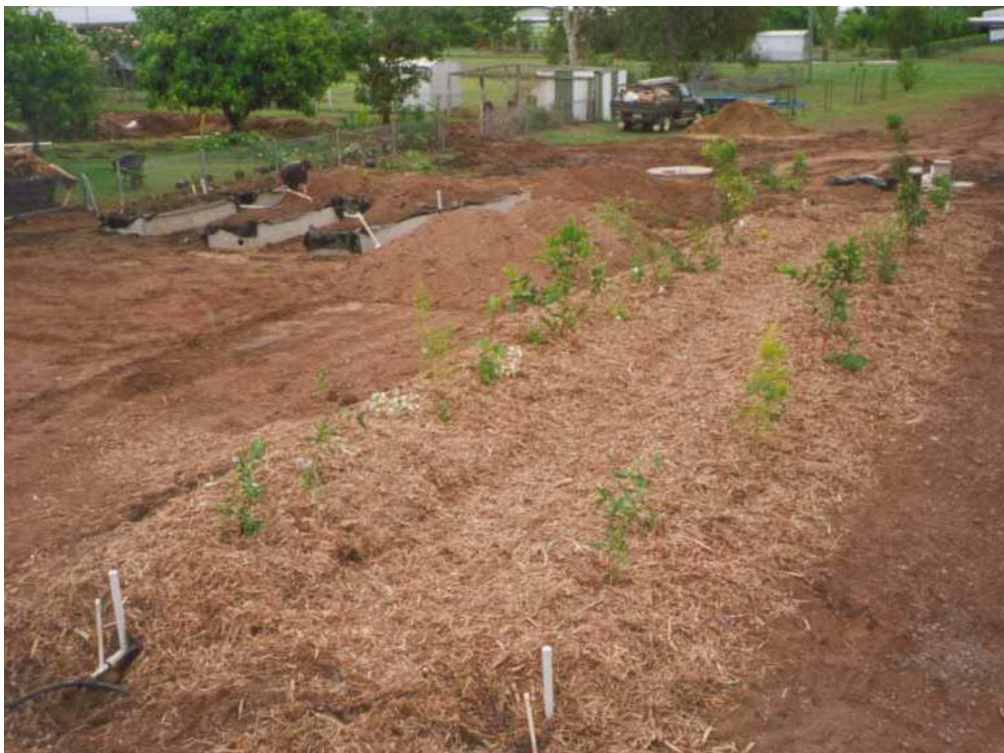
Figure 5.1 Bamboo just after planting at the St Lawrence domestic site

Clumping varieties of bamboo was selected for use in the trial because it grew quickly and used relatively large quantities of water and nitrogen (Kleinhenz and Midmore 2001). Figures 5.1 and 5.2 show how quickly the bamboo grew at the St Lawrence domestic site. The bamboo in Figure 5.1 is planted at the start of the channel just after the venturi air system; this bamboo in Figure 5.2 has grown up to five metres in height in one –year.

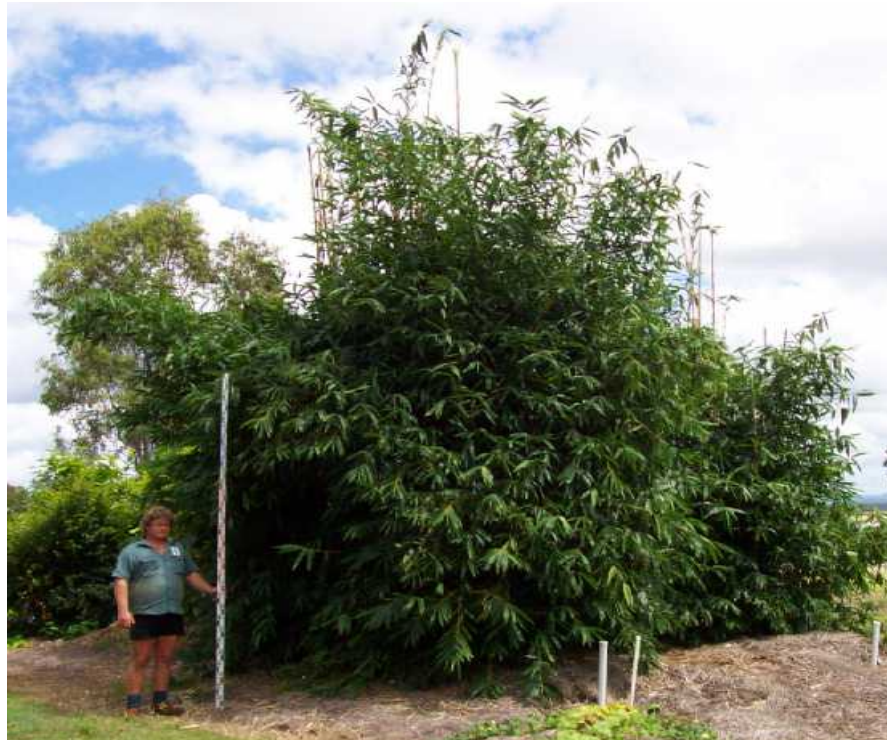
Figure 5.2 Bamboo one-year after planting at the St Lawrence domestic site

The majority of bamboo species only flower and fruit very rarely. However bamboo does have a large leaf area for transpiration and biomass for nutrient use. Bamboo clumps can be cutback and reduced if size becomes a problem. Fruit-trees were selected for the trial as they may have elevated nutrient and water requirements. Fruit was also required for a microbiological study on potential pathogens (Section 5.4). A limited amount of exotic ornamental plants were chosen for the trial. Endemic Australian natives were selected and obtained from local Landcare groups. These plants were important as they were suited to the climate, supported local flora biodiversity and encouraged local fauna. A mixture of these broad types of plants was selected for most sites.

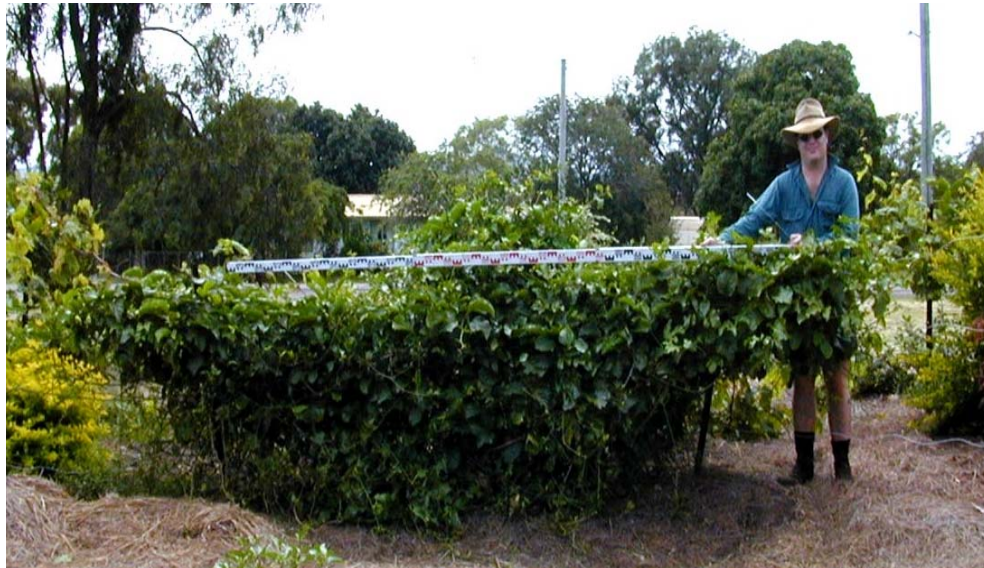
Figure 5.3 Passion-fruit before grazing by marsupials

*Bambusa oldhamii*. The grazing did not kill members of either plant species but did reduce the leaf-area; particularly in the passion-fruit (see Figures 5.3 and 5.4).

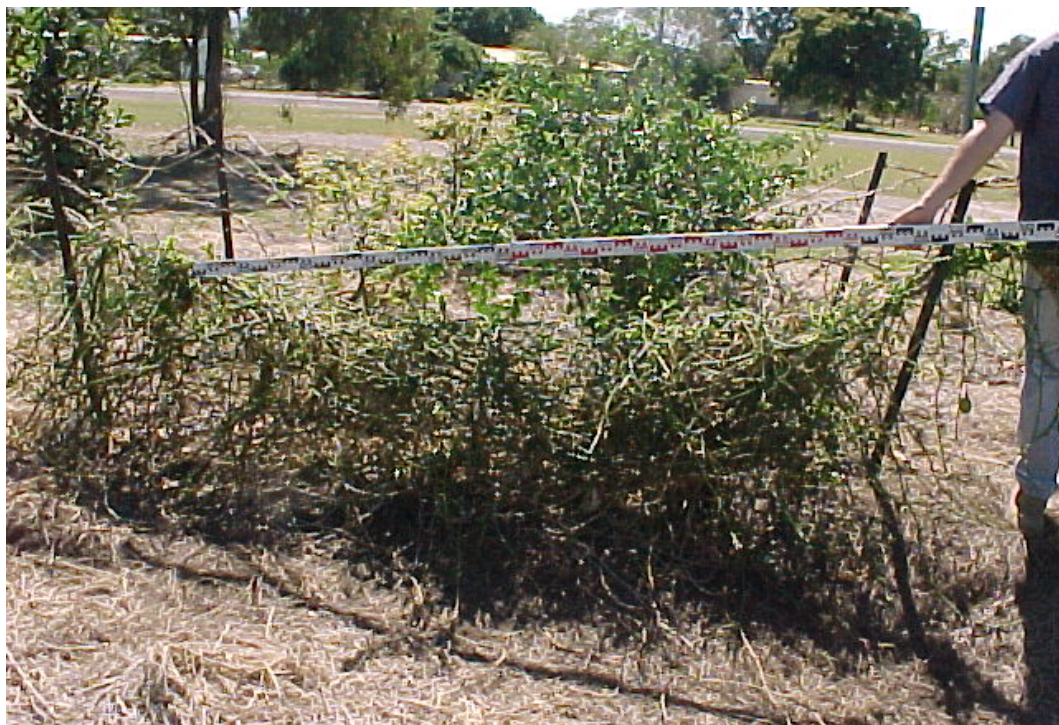
Figure 5.4 Passion-fruit after grazing by marsupials

It is thought that the marsupials came into town and grazed on the plants in the RET channels because of the drought conditions in their normal environment. Grazing only occurred during extended periods of low-rainfall.

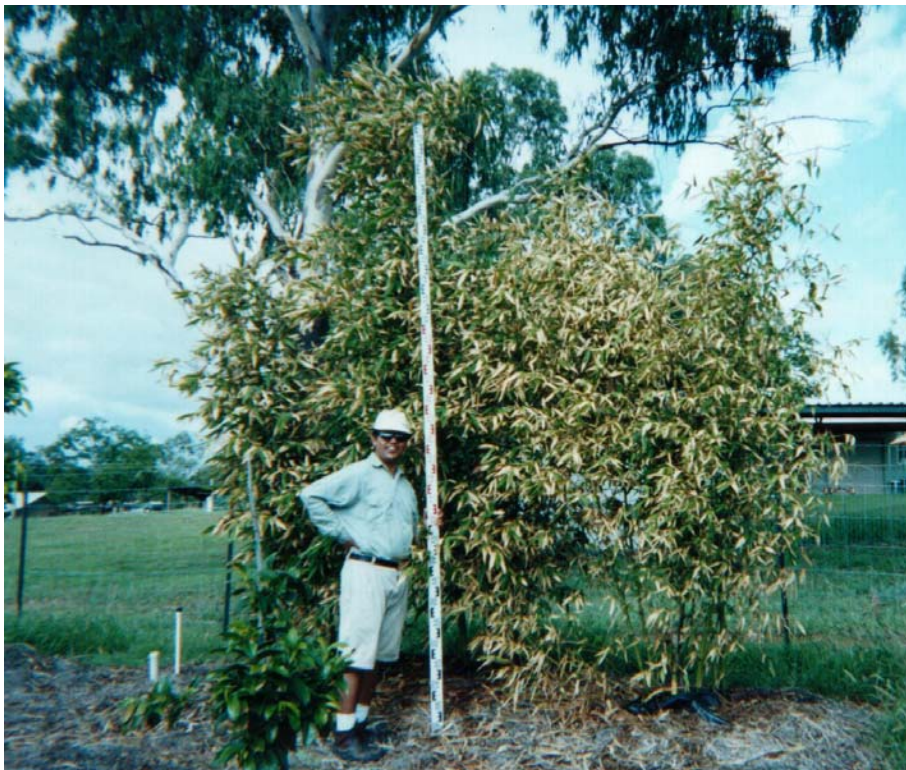
Figure 5.5 Bamboo at Sapphire Site after phytotoxic accumulation in soil

The Sapphire site was the only RET system where it was determined that adverse impacts from effluent irrigation had resulted in plant deaths. Just over 70% of the plants within the RET channels died; all of them exhibiting toxicity effects caused by salinity (see Figure 5.5).

Not all plants died within the channels; the *Melaleuca nervosa* and *Diospyros digyna* (Chocolate pudding fruit) plants survived; the plants did show some effects of phytotoxicity, such as browning around the leaf edges, the plants did continue to transpire and use nutrients. The long-term survival of these plants at this site is expected.

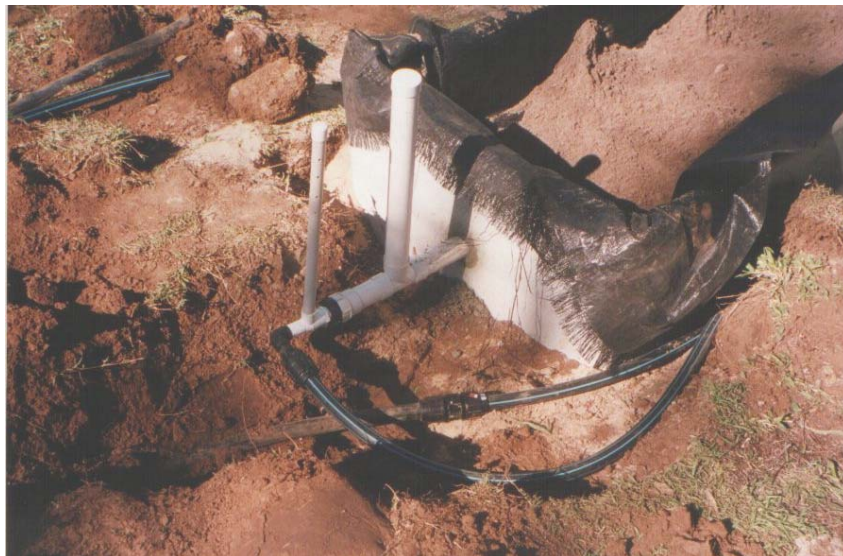
Figure 6.1 Original Venturi valve

A Venturi valve system was used to aerate the effluent as it entered the channel (Figure 6.1). The Venturi valves were constructed of PVC and had a 400 mm long, 20 mm diameter perforated PVC pipe as an air-intake mechanism. If multiple runs of RET channel were installed at the site a tap was installed directly before the Venturi valve to regulate the amount of effluent each irrigation run received. Problems occurred with the taps due to non-authorised human interference. Members of the public upon occasion altered the settings of the taps causing some channels to receive relatively high amounts of effluent and others a quite restricted

volume. The alteration of the taps adversely affected the performance of the Venturi valves as effluent was not be pumped through the aeration system in the desired pressure range. If the volume of effluent passing though the Venturi valve was too high the pressure sometimes forced it out the air-intake pipe, causing a potential public and environmental health risk. On two occasions during the course of the experiment foreign objects blocked the intake of the Venturi valve (Rockhampton and Anakie trial sites). This caused high water levels within the holding tank. It was also noted at the St Lawrence Domestic, Anakie, Rubyvale, and Yaamba sites that insects built nests in the perforations of the 20 mm diameter PVC air-intake pipe.

The aeration and effluent distribution system were improved by minor infrastructure changes. The Venturi valve was moved to inside the holding tank. The air-intake pipe goes through the holding tank lid. The aeration system is now designed so that

approximately half of the aerated effluent is immediately discharged back into the holding tank. This reduces the risk of foreign object blockage and it is designed so that the pressure never reaches the required level for aboveground discharge through the air-vent pipe. This eliminates the potential environmental and public health risk. The additional benefit to this design is that both the effluent entering the RET channels and in the holding tank have relatively higher levels of oxygen.

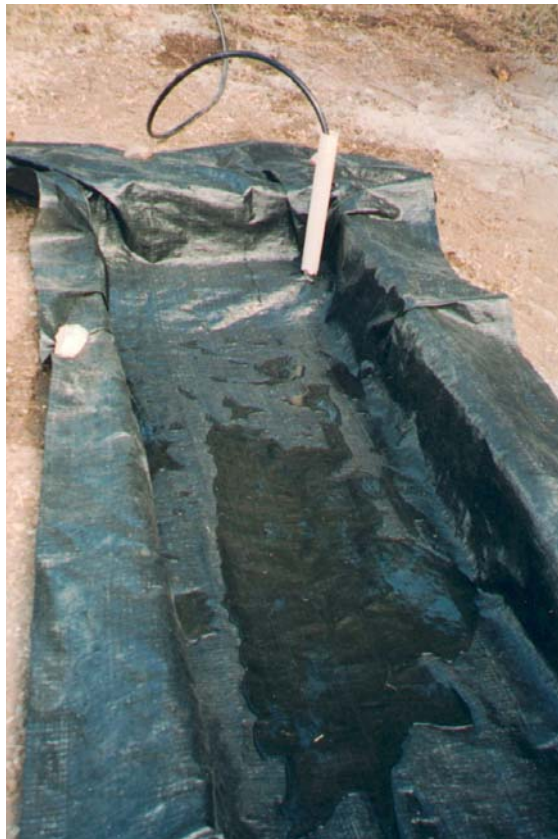
Figure 6.3 Terra-firma matting/Geo-Fabric

The aim of the terra-firma matting/geo-fabric in the trial was to provide a physical barrier (see Figure 6.3) that prevented the soil from infiltrating and clogging the aggregate layer while allowing the transfer of effluent into the soil column.

No clogging of the aggregate layer with soil was encountered in the trial. The unimpeded transfer of effluent through the matting into the soil column did not occur. At the Rockhampton site soil was excavated from 3 channels. During these excavations it was observed that the effluent transfer rate through the matting increased when it was physically manipulated and the silt clogging the pores was

disturbed. New geo-fabrics have been developed since this trial was started that are reported to be clogging resistant and give sustainable hydraulic transfer rates.
