Geography of the Lower Fitzroy and navigation problems

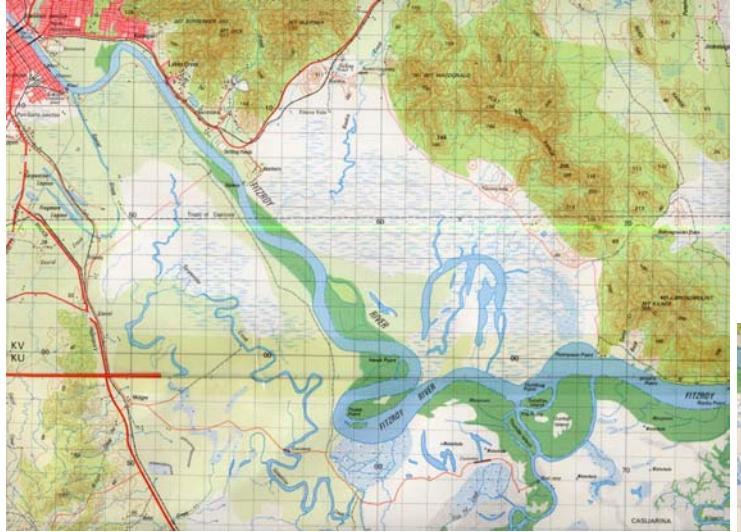
Lower Fitzroy River, before the 1991 flood broke through the base of Pirate Point peninsula (Natmap Sheet 9050/1, 1983)

A topographic map of the Fitzroy estuary readily indicates why the Fitzroy River has proved difficult for shipping to negotiate. The river meanders across a broad, flat floodplain and a delta of saltpans and mudflats before emptying into Keppel Bay. In the years before the late 1960s when construction of the Rockhampton barrage halved the distance of the tidal influence, the river had an almost imperceptible fall to the sea of only 1.5cm/km in the 100km from the previous limit at Yaamba.¹

If Rockhampton could have been established closer to the mouth of the river, as in the case of Brisbane, and especially below the hairpin bend of Pirate Point, the possibilities for development would almost certainly have been greater. As the map of the estuary clearly indicates however, there was no such possible site for settlement due to almost all the riverside land downstream being prone to inundation during floods. As it was, the city's location left it vulnerable to isolation and even to periodic major incursions of floodwater into urban areas. The record events of 1991, 1954 and especially of 1918 were evidence of that. There were also stories of mega-floods in local Aboriginal memory.

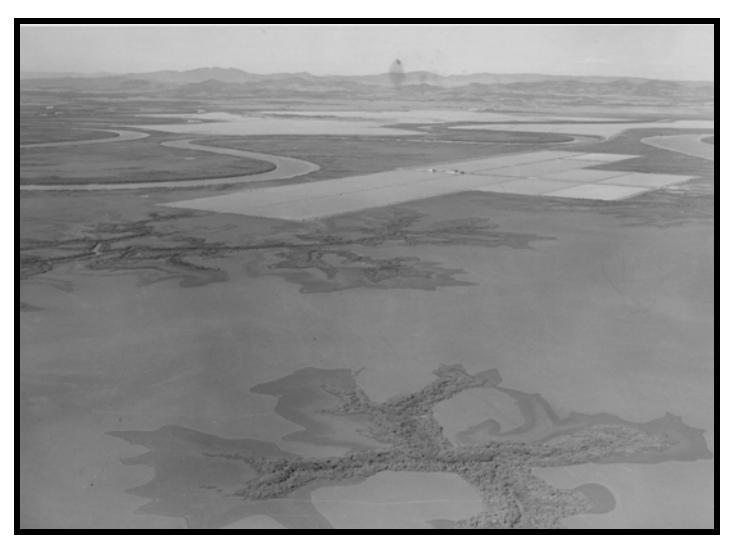
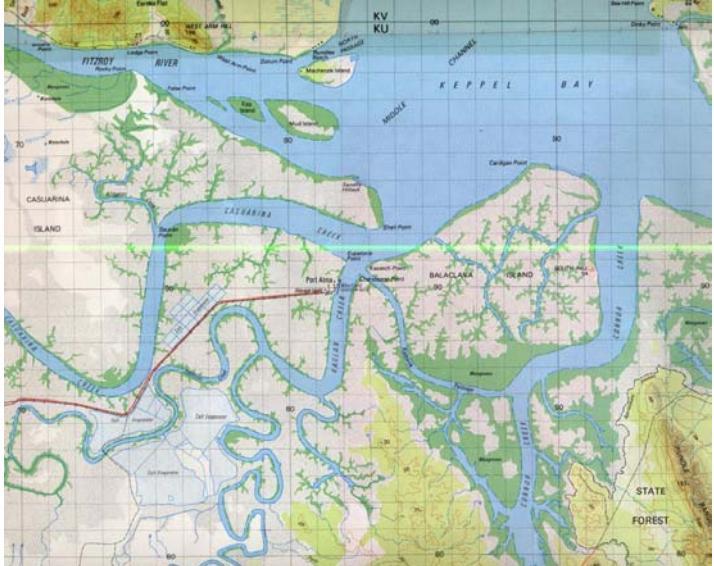
(CCQC)

Aerial photograph of the delta, looking south-west, showing mangroves, mud-flats and saltpans with salt evaporators. Casuarina Crk (L), Inkerman Crk (C) and Raglan Crk (R).

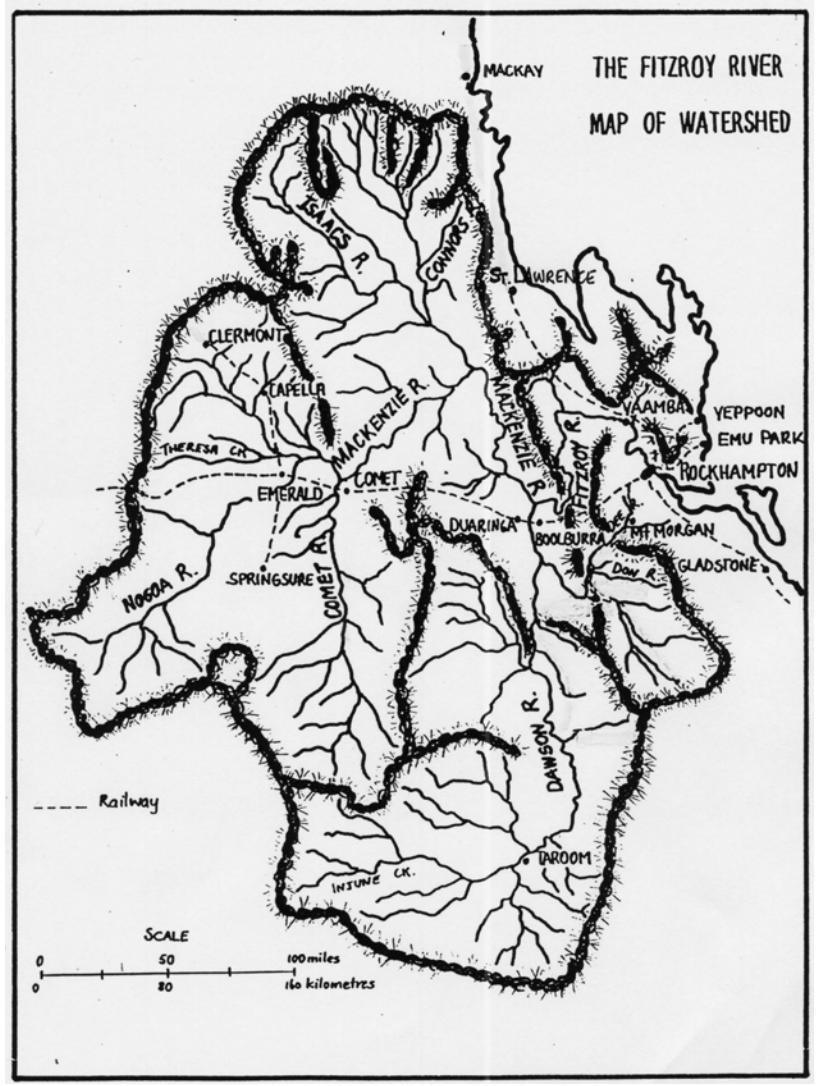
Adapted from a map drawn by the General Manager, Queensland Railways Central Division, in Rhodes, *Port of Rockhampton*.

As the historical map below indicates, the Fitzroy also drains an enormous area—the second largest catchment in Australia. As still happens today, high run-off occurred during intermittent torrential summer rains and caused erosion throughout the river basin so that the river and its tributaries carried a heavy load of silt, sand and gravel. Periodic major flooding throughout the river system increased the amount of sediment carried downstream into the Fitzroy.²

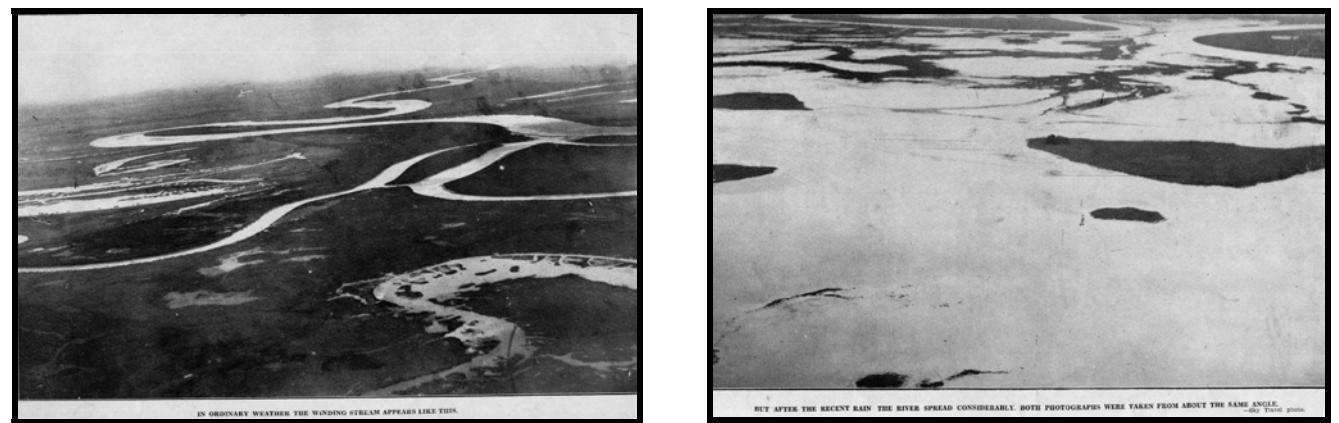
Aerial photograph of river floodplain showing Pirate Point and Dunlop Island before (L) and during (R) a major flood, probably 1928. (*Queenslander*,1929)

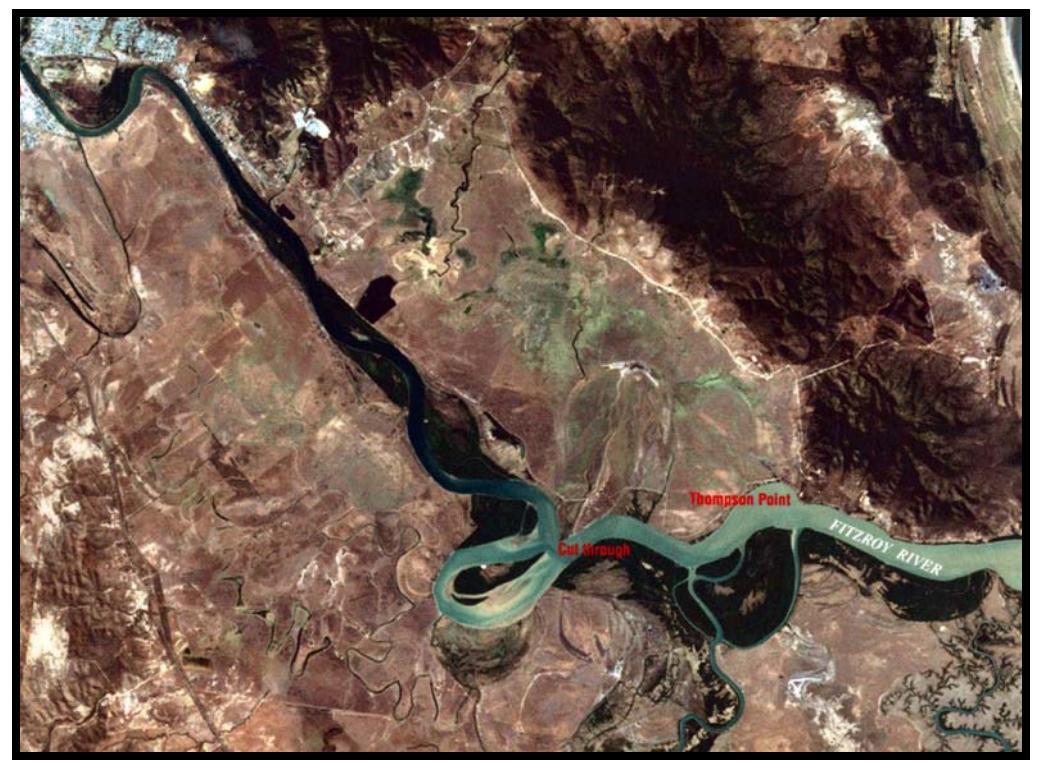
Post-1991 photo-image of Fitzroy River showing the cut-through at the base of Pirate Point and accelerated sedimentation in Winding Reach. (Coastal CRC, 2002)
